# FACILITY COMPLIANCE AUDIT REPORT

# Division of Waste Management Solid Waste Section

Date of Audit: 21 June 2011 Date of Last Audit: 15 February 2011

Miller Farm LCID Landfill Miller Farm Road Morehead City, NC 28557

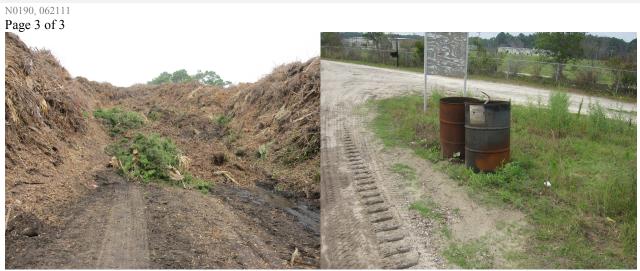
Active working area needing cover and grading

Containers for collection of unpermitted materials

- 9) The waste type being disposed is LCID waste only; no unacceptable waste streams were noted during this audit.
- 10) The active working area is approaching one acre in size. \*Please ensure that the active working face is covered monthly or when it approaches one acre in size, whichever occurs first.

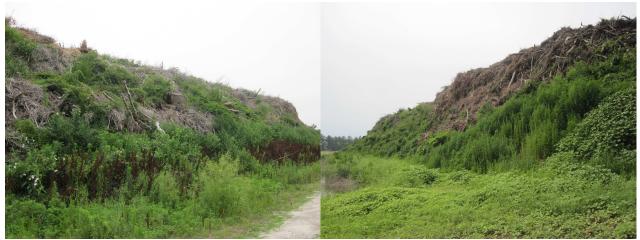
Sideslopes needing cover and grading

- 1) This facility is a Land-Clearing and Inert Debris Landfill Notification.
- 2) This facility is monitored by a 24 hour security camera at the facility entrance.
- 3) This facility is secured by a locked gate at the facility entrance and has controlled access for safety.
- 4) Proper signage is posted at the facility entrance stating the facility emergency contact number and types of waste accepted.
- 5) The access road to the facility is being managed properly at this time.
- 6) The perimeter road is well maintained, providing for access around the facility.
- 7) Receptacles are maintained at the site for the removal and management of unpermitted wastes.
- 8) All the landfill sideslopes have not been covered adequately and graded to promote positive drainage of surface waters.\*Within thirty days of receipt of this audit report, please compact, cover and grade all sideslopes at a

- slope of not greater that 3:1. All covered and graded areas should then be seeded and mulched to establish a groundcover suitable to prevent erosion of the landfill cap.
